USARTL-TR-78-48

**ICING TESTS OF A UH-1H HELICOPTER WITH AN
ELECTROTHERMAL ICE PROTECTION SYSTEM UNDER
SIMULATED AND NATURAL ICING CONDITIONS**

**R. H. Cotton
LOCKHEED-CALIFORNIA CO.
P.O. Box 551
Burbank, Calif. 91520**

Final Report for Period 31 January 1978 - 31 March 1978

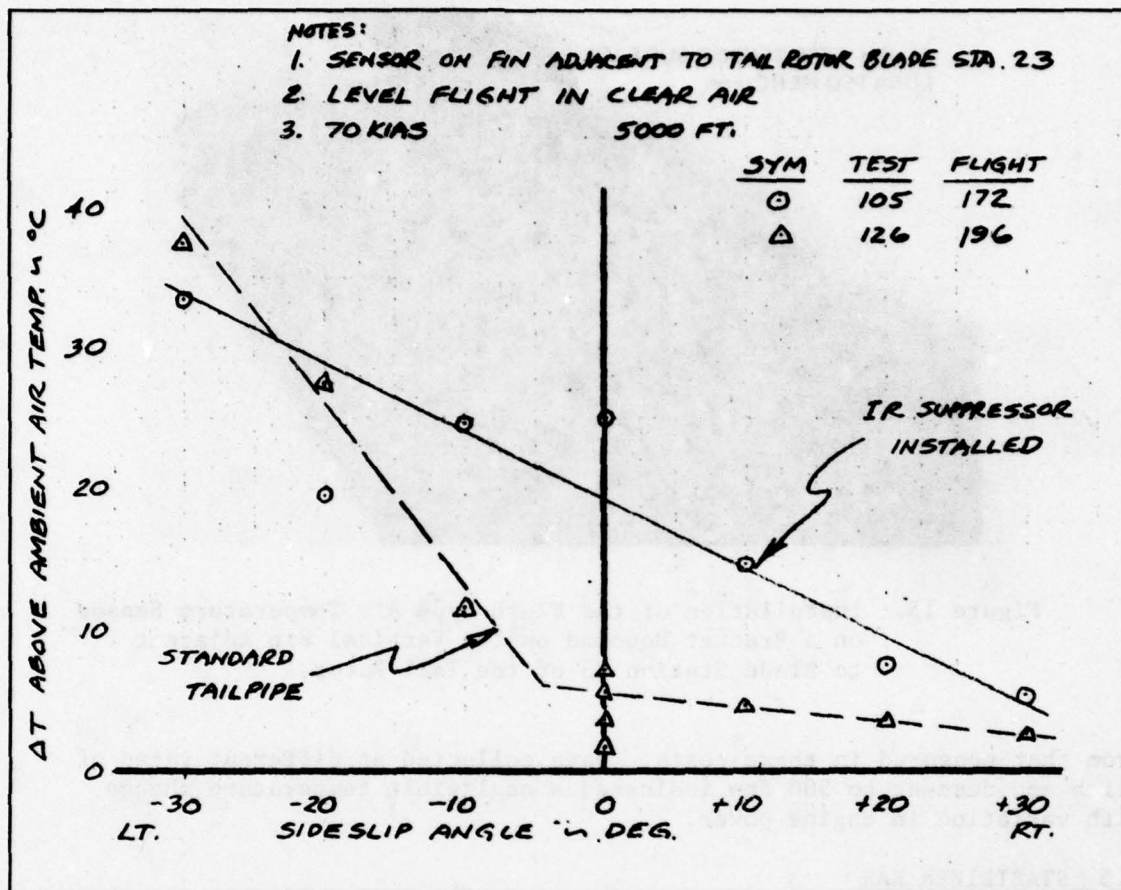
Figure 16. Air Temperature Increase Above Ambient at Tail Rotor With and Without the Infrared Suppressor Installed.

The data from the flight survey are shown in Figure 16. The test consisted of stabilized sideslips to the left and the right using a windshield-located yaw string as a sideslip indicator. Although there is some scatter in the test data as might be expected considering the type sensor, the location, and the combination of flows involved, the results obtained this year with the IR suppressor installed are in general agreement with the results obtained for the same configuration last year. These data show that, in clear air, the air temperature at the tail rotor is increased approximately 20°C above ambient due to engine exhaust heating. In addition, left sideslip results in increasing temperature and right sideslip results in decreasing temperature, indicating that the exhaust plume passes to the left side of the tail fin.

With the standard exhaust tailcone installed, Figure 16 shows that at zero sideslip, only approximately a 5°C increase is realized. This is as would be expected, since the exhaust is not directed upward with the standard exhaust cone and therefore is deflected further downward by the rotor downwash by the time it reaches the tail rotor location. It should be noted that these data are for clear air; therefore, flight in an icing cloud would tend to cool the exhaust in proportion to the amount of moisture present and thus reduce the temperature increase above ambient

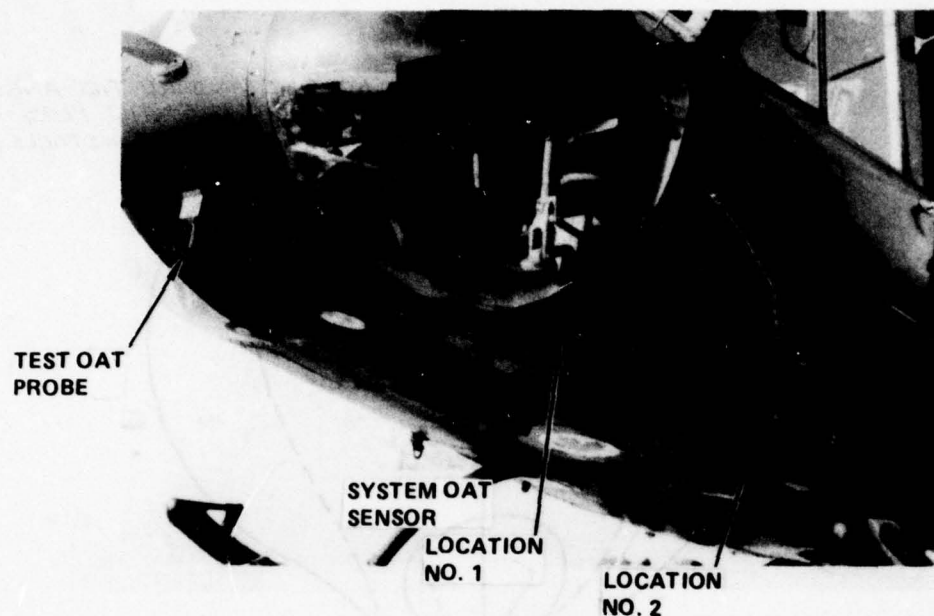
Figure 18. Two Locations Evaluated for the Deicing "SYSTEM OAT" Flush-Type Sensor and the Location of the "TEST OAT" Probe.

Flight results during this year's testing showed that the underside of the nose was an unsatisfactory location because it measured 5° to 10°C warmer than the actual temperature and was not consistent. The basis for determination of the actual outside air temperature was a shielded-type resistance-element total air temperature probe normally accepted as a standard and used extensively in aircraft performance testing. This type is relatively expensive and incorporates a probe deicing feature. The LH sensor was relocated to the fuselage side just below the copilot's door. This resulted in considerable performance improvement in forward flight, but was now sensitive to sunlight and still gave inconsistent readings in hover. Figure 18 shows the two locations that were tried for the flush-type system OAT sensor and also the test OAT probe installation.

It was found that the standard UH-1H outside air sensor located in the upper left-hand corner of the pilots windshield always was in extremely close agreement with the "Test OAT" probe both in forward flight

Based on this experience, it appears that a satisfactory OAT signal to a deicing controller can be obtained with a cabin roof top sensor location on the UH-1H. One possibility would be to change the standard ship's probe to an electrical resistance type rather than the present bimetallic mechanical indicator type. Another possibility would be to supplement the present mechanical indicator with a second probe in the same location but through the LH windshield. The second sensor would deliver an electrical signal to the deicing controller and the mechanical cockpit readout would be retained.

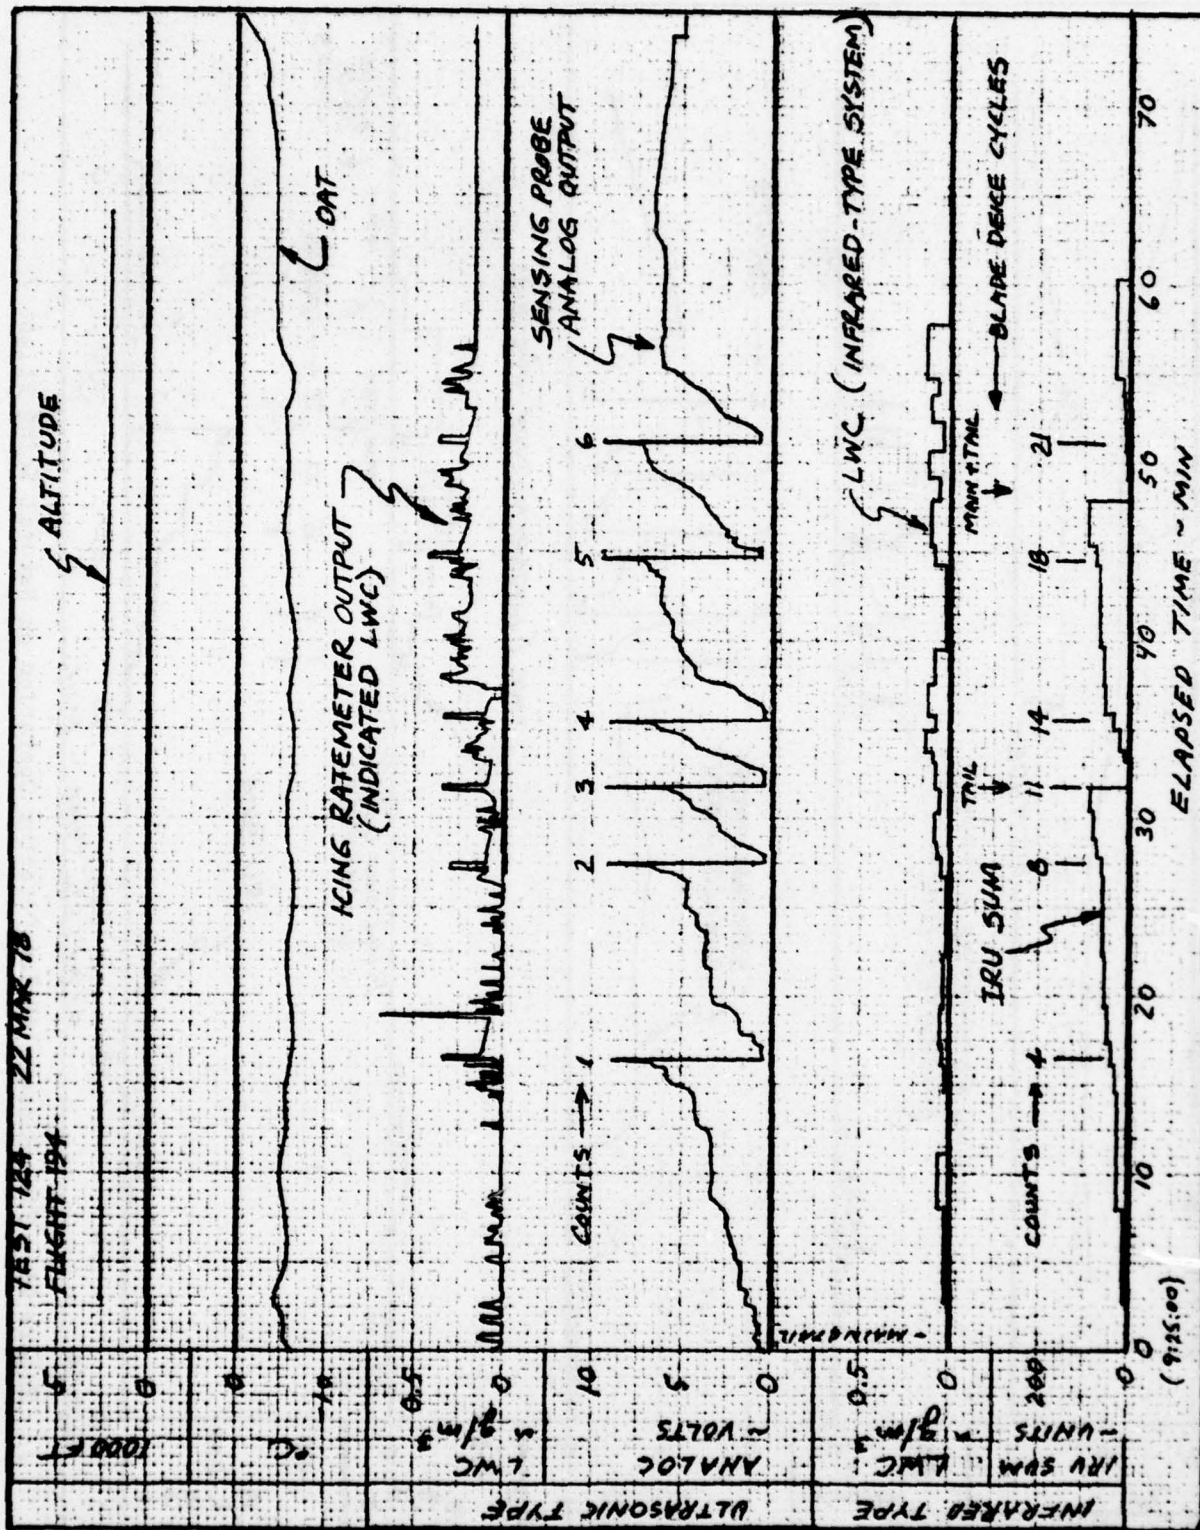
Figure 22. Time History of Ice Detector Operation on Natural Icing Flight 9.

The zero shift, mentioned previously, did not appear on Flight 190 (Figure 21) but does show after time 38 minutes on Figure 22. Note that the ultrasonic-type LWC does not return to zero and the LWC indication is more than twice that of the infrared type after the zero shift. This can also be noted on Figure 6 after time 18 minutes. In addition, the spikes on the analog voltage trace at the ice detector probe deice point were not characteristic of last year's data (See Figures 17 through 21 of Reference 4). During the period of the zero shift, the ratio of the number of ice detector cycle counts for the ultrasonic to the infrared decreased also. Presumably these problems will be corrected in the production version of the new aspirated-probe configuration of this detector.

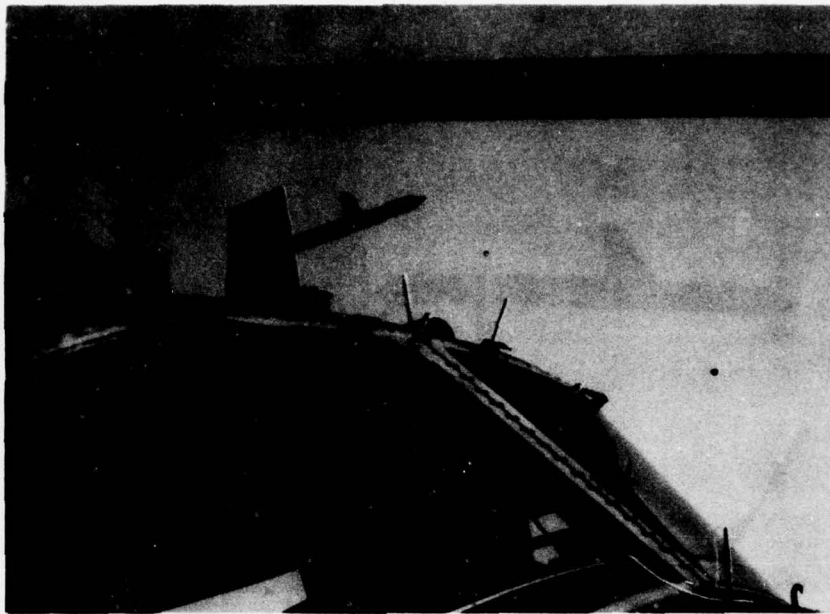
Figure 23. Three of the Stick-Like Masts Used in the Ice Detector Location Survey.

Figure 23 also shows something of interest relative to the battery compartment vent tube icing problem that was indicated from HISS tanker icing tests in 1975 and reported in Reference 1. Inspection of the ice catch on the icing mast located at the base of the windshield center near the battery vent, showed very little, if any, ice accretion on the post near its base up to the height of the battery vent. This indicates that the smaller size droplets in a natural icing environment do not impinge on the battery vent tube but pass over it as opposed to the larger droplet size of the HISS cloud. Therefore, it appears that in natural icing it is unlikely that the vent will ice up and clog; additional experience in icing is necessary to confirm this.

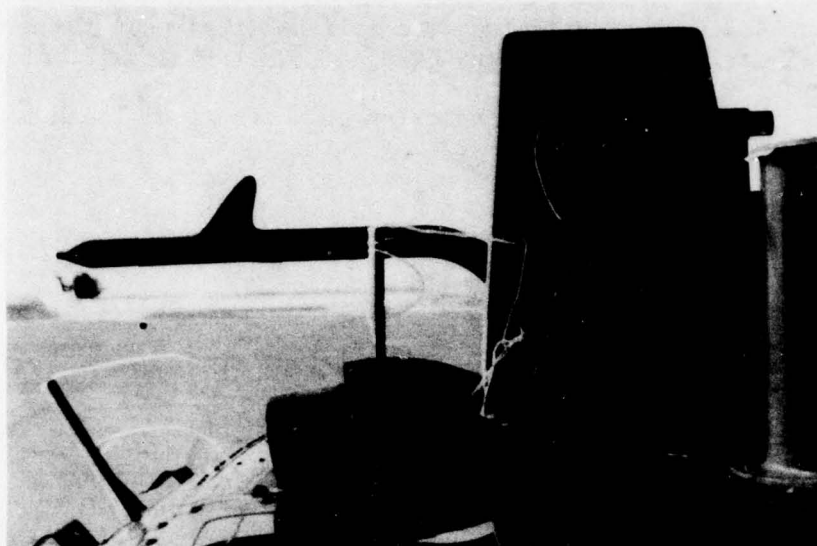
It was concluded from the observations that any of the test locations would be satisfactory and that on the top of the fuselage, even at their present fuselage station, the 12-inch-high pylons are unnecessary. Close inspection of Figures 25 and 26 shows ice on the leading edges of both the UHF antenna and the existing blunt-nosed pylons for the ice detectors down almost to their base. The normal 3 to 3.5-inch height of the sensing element from the mounting base of either type ice detector is judged to be adequate. The recommended location for a production ice detector would be on the cabin roof oriented in the same spot as the rooftop pitot-static airspeed probe mount but on the LH side of the UHF antenna. However, this location might present a problem accommodating the plumbing and electrical connections inside the cabin. The next recommendation would be at the outboard-forward edge of the test aircraft's LH ice detector pylon (approximately F.S. 49 and BL 12). This locates it in an ideal structural modification area, which presents an easy access for plumbing and requires no mast extension; it is also outboard of any shadow effect from the upstream fresh air scoop and is on the favorable side of the aircraft from the rotor downwash flow field standpoint.

Figure 25. Close-Up of the Ice Detector Location Survey Probes Located on the Cabin Roof, Following a Natural Icing Flight.

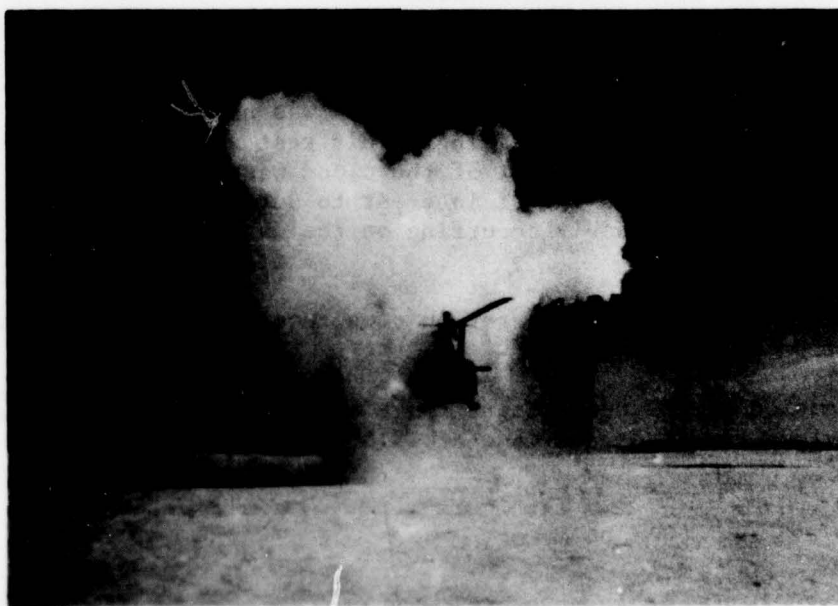
Figure 28. Rear View of Test Aircraft in the Spray Rig on Bright Clear Day With 0.7 g/m^3 LWC and -7°C OAT.

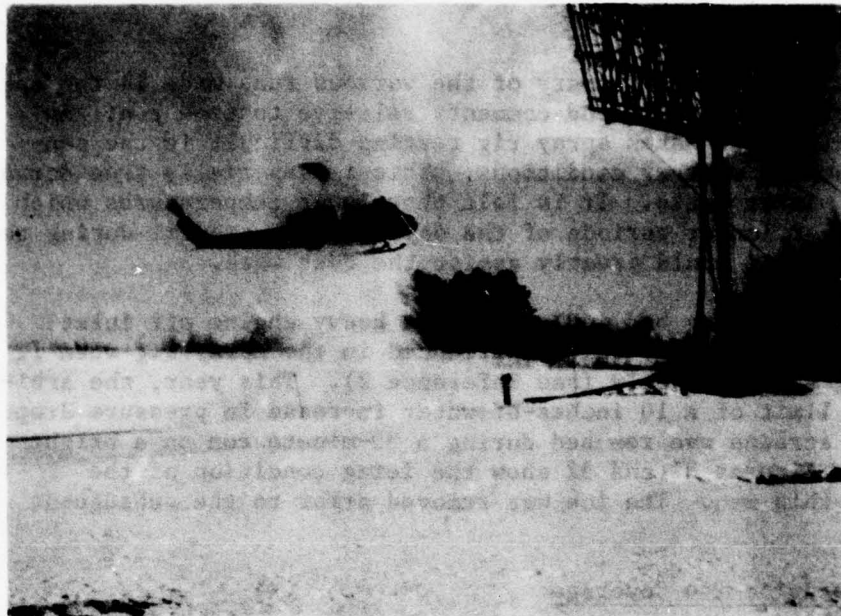
Figure 29. Spray Rig Operations With a 10-mph West Wind (cloud is 0.7 g/m^3 at -6.5°C OAT).

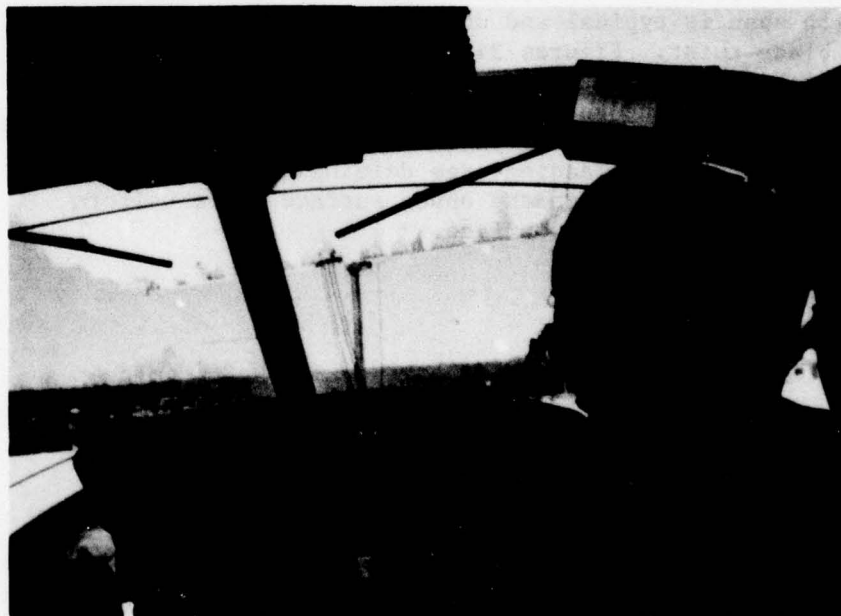
Figure 30. View From the Cockpit During a Spray Rig Test Prior to Cloud Pulldown (20-mph wind and 0.55 g/m^3 at -11°C).

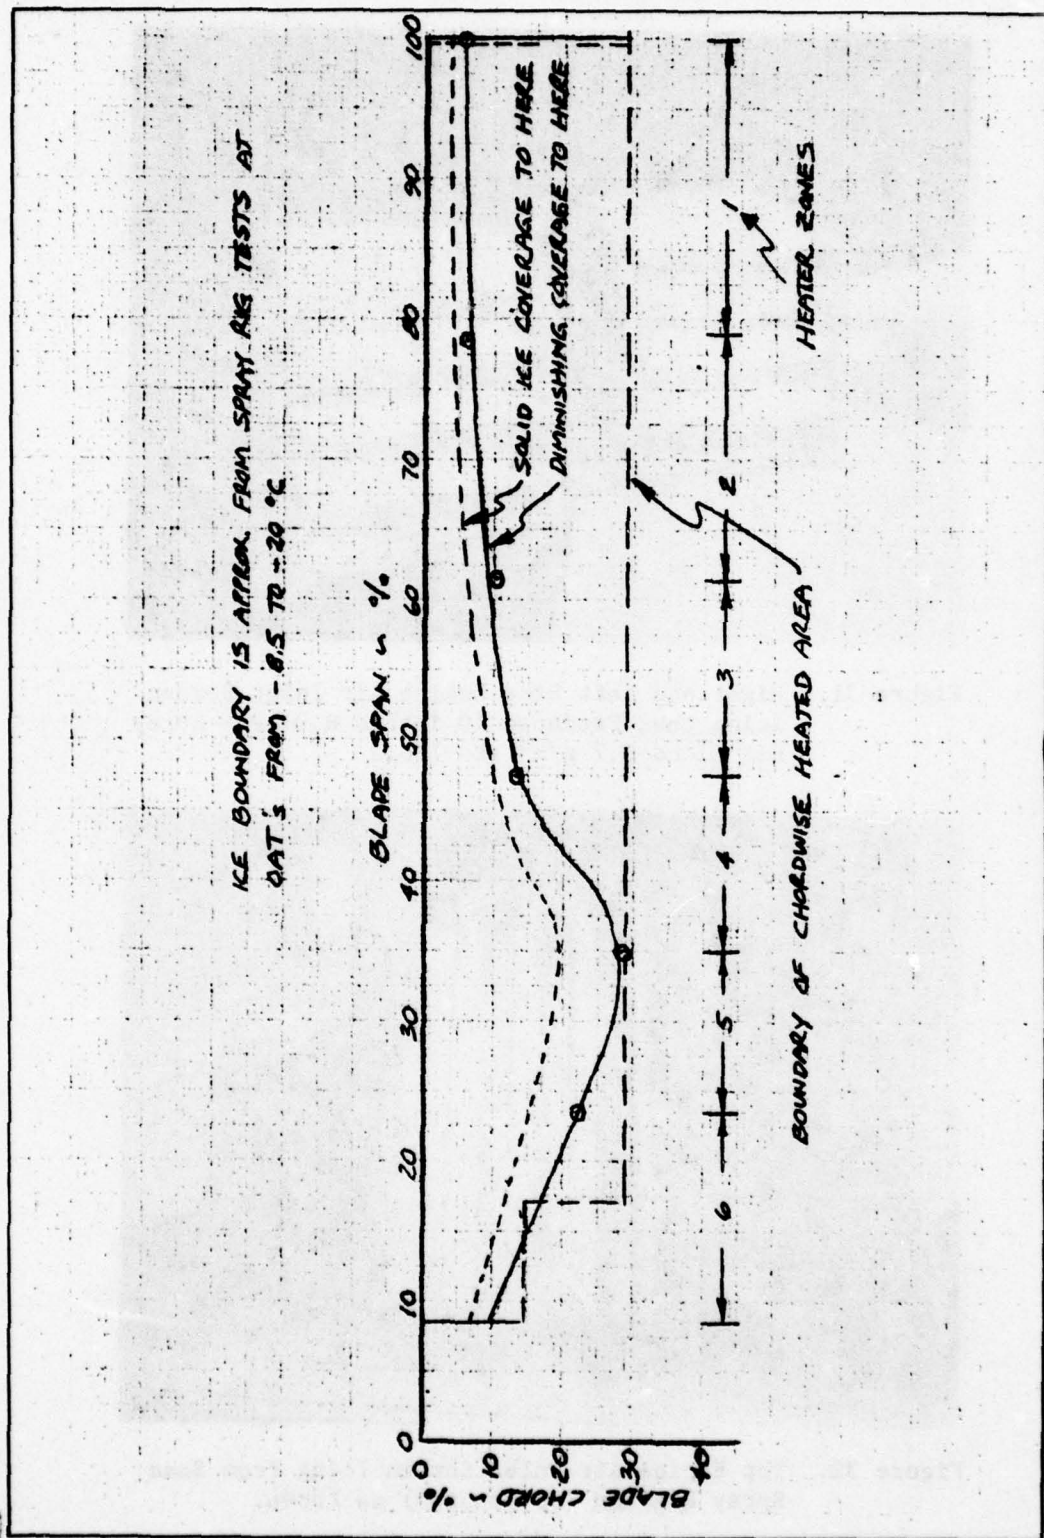
Measurements were made of the extent and spanwise distribution of main rotor blade chordwise ice coverage. Figure 33 shows the quantitative results for the lower surface. The pattern shown is typical for the spray rig and shows a maximum chordwise coverage of 29 percent chord at the 35-percent span location. The rapid decrease with span is typical and undoubtedly related at least in part to blade twist. Figures 34 and 35 are photographs of a typical distribution and texture on the lower surface of the blade. The upper surface usually has a fairly uniform one-half to three-quarters of an inch coverage which would be approximately 3-1/2 percent chord. The leading-edge deicing heater coverage extends to 12 percent chord on the upper surface and a uniform 29 percent chord on the lower surface.

Figure 33. Chordwise Extent of Ice on Main Rotor Blade Lower Surface.

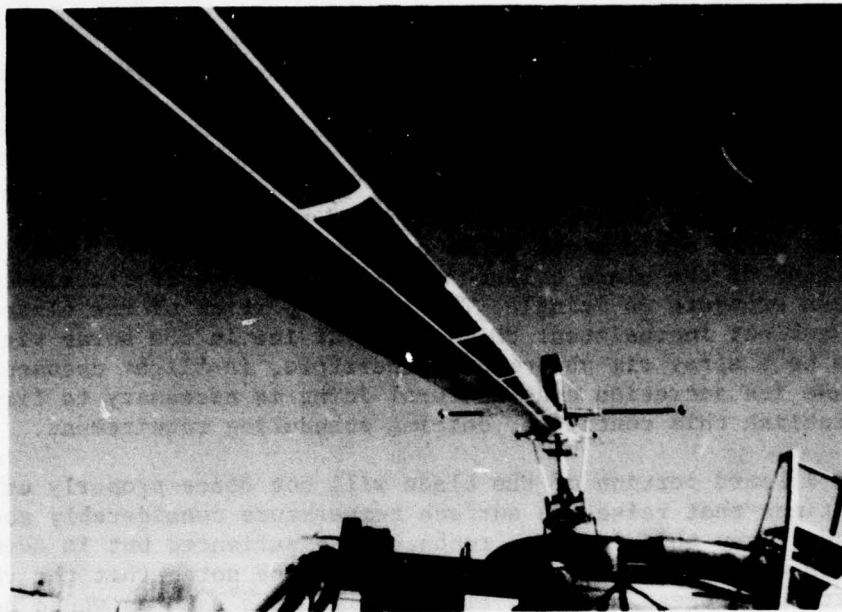
Figure 34. Typical Chordwise Ice Distribution From Spray Rig Operations (0.55 g/m^3 at -11.8°C).

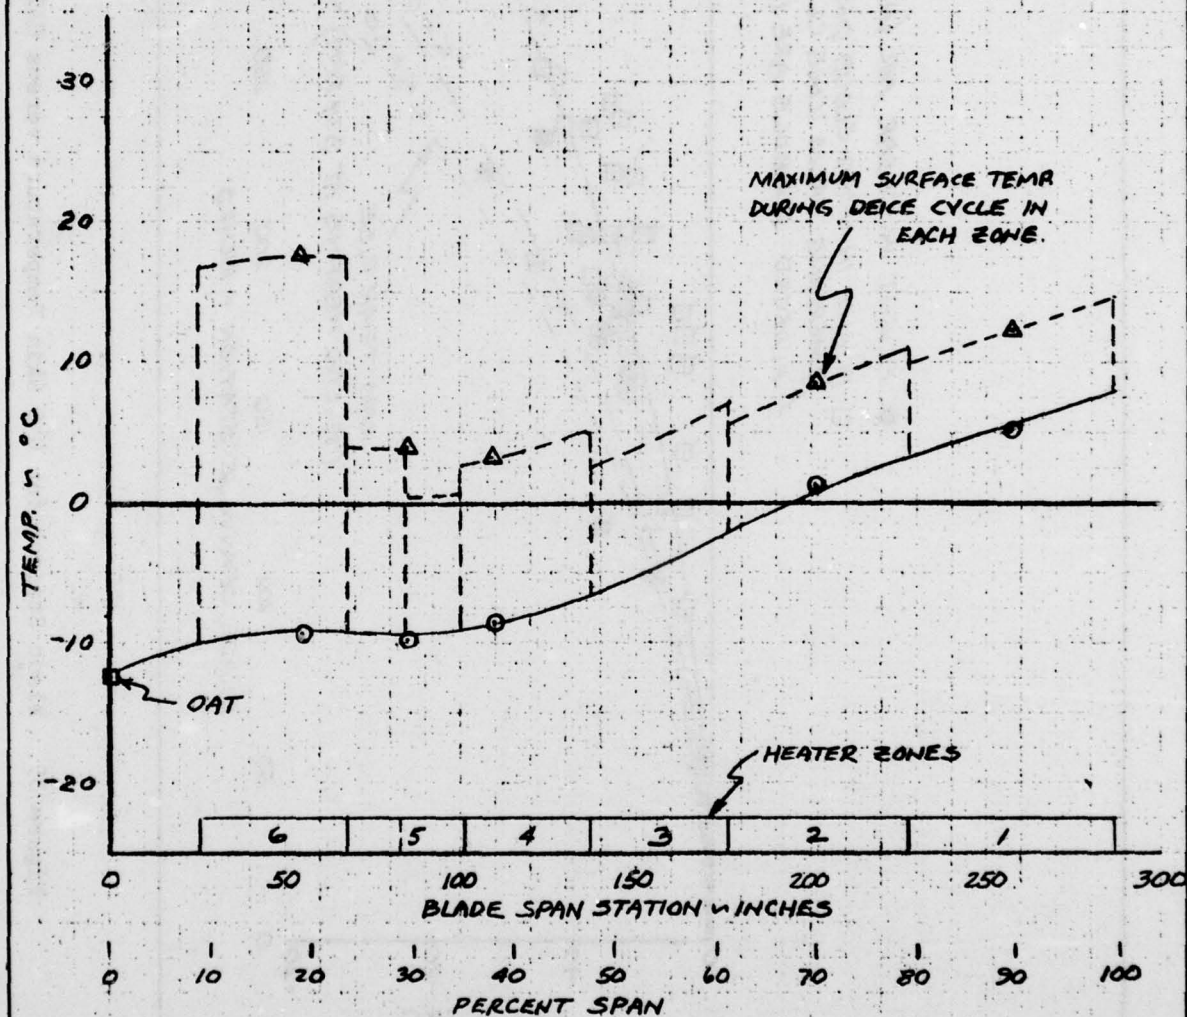
An interesting observation that can be made referring to Figure 38, is the fact that even though the heater-on time is constant for a given zone because the blade kinetic heating increases with blade radius, the blade surface temperature passes above 0°C in the tip-to-root sequence also within the zone as blade zone heating takes place. This characteristic further enhances the tip-to-root shedding in smaller increments than the full zone width geometry implies. This is apparent in hub camera pictures of blade deicing sequences, which show many cases of ice shedding in approximately one-half zone increments rather than a full zone at a time.

1. BLADE DEICE CYCLE IN NATURAL ICING CLOUD OF 0.1 g/m^3 LWC
2. TEST 114 FLIGHT 180 11 MAR 1978 7400 FT. 90 KIAS
3. CONTROLLER SET FOR 200 VOLTS & -12.5°C OAT

Figure 38. Main Blade Surface Temperature During Blade Deice Cycle on a Natural Icing Flight.

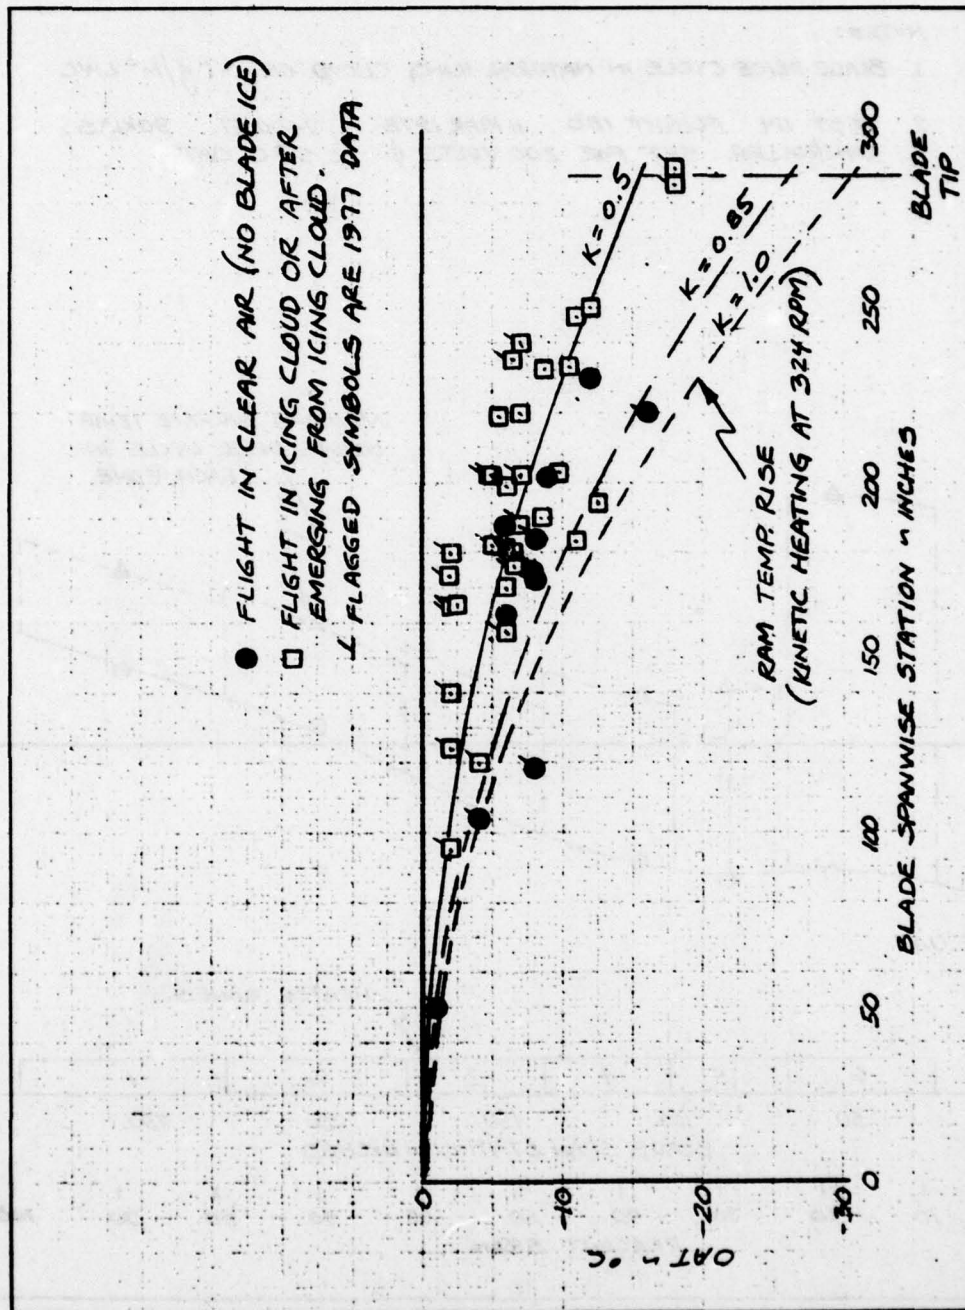
Figure 39 is a plot from data like that shown in Figure 38 of the spanwise station that the blade temperature variation crosses 0°C versus outside air temperature. This plot is an indication of the spanwise extent of blade icing for any air temperature. It also is an indication of the amount of kinetic heating or "net kinetic heating" of the blade. Considerable scatter is apparent in the data, indicative of the difficulty mentioned previously in defining spanwise temperature distributions that are considered representative of specific operating conditions. Because of the inconsistencies that have been noted in examining the available test data, the only differentiation

Figure 39. Blade Station for 0°C Skin Temperature versus OAT.

It appears from Figure 39 that to determine the heater-on time required to deice (raise the surface temperature to 0°C), the assumption that 50 percent net kinetic heating is realized is still a valid one.

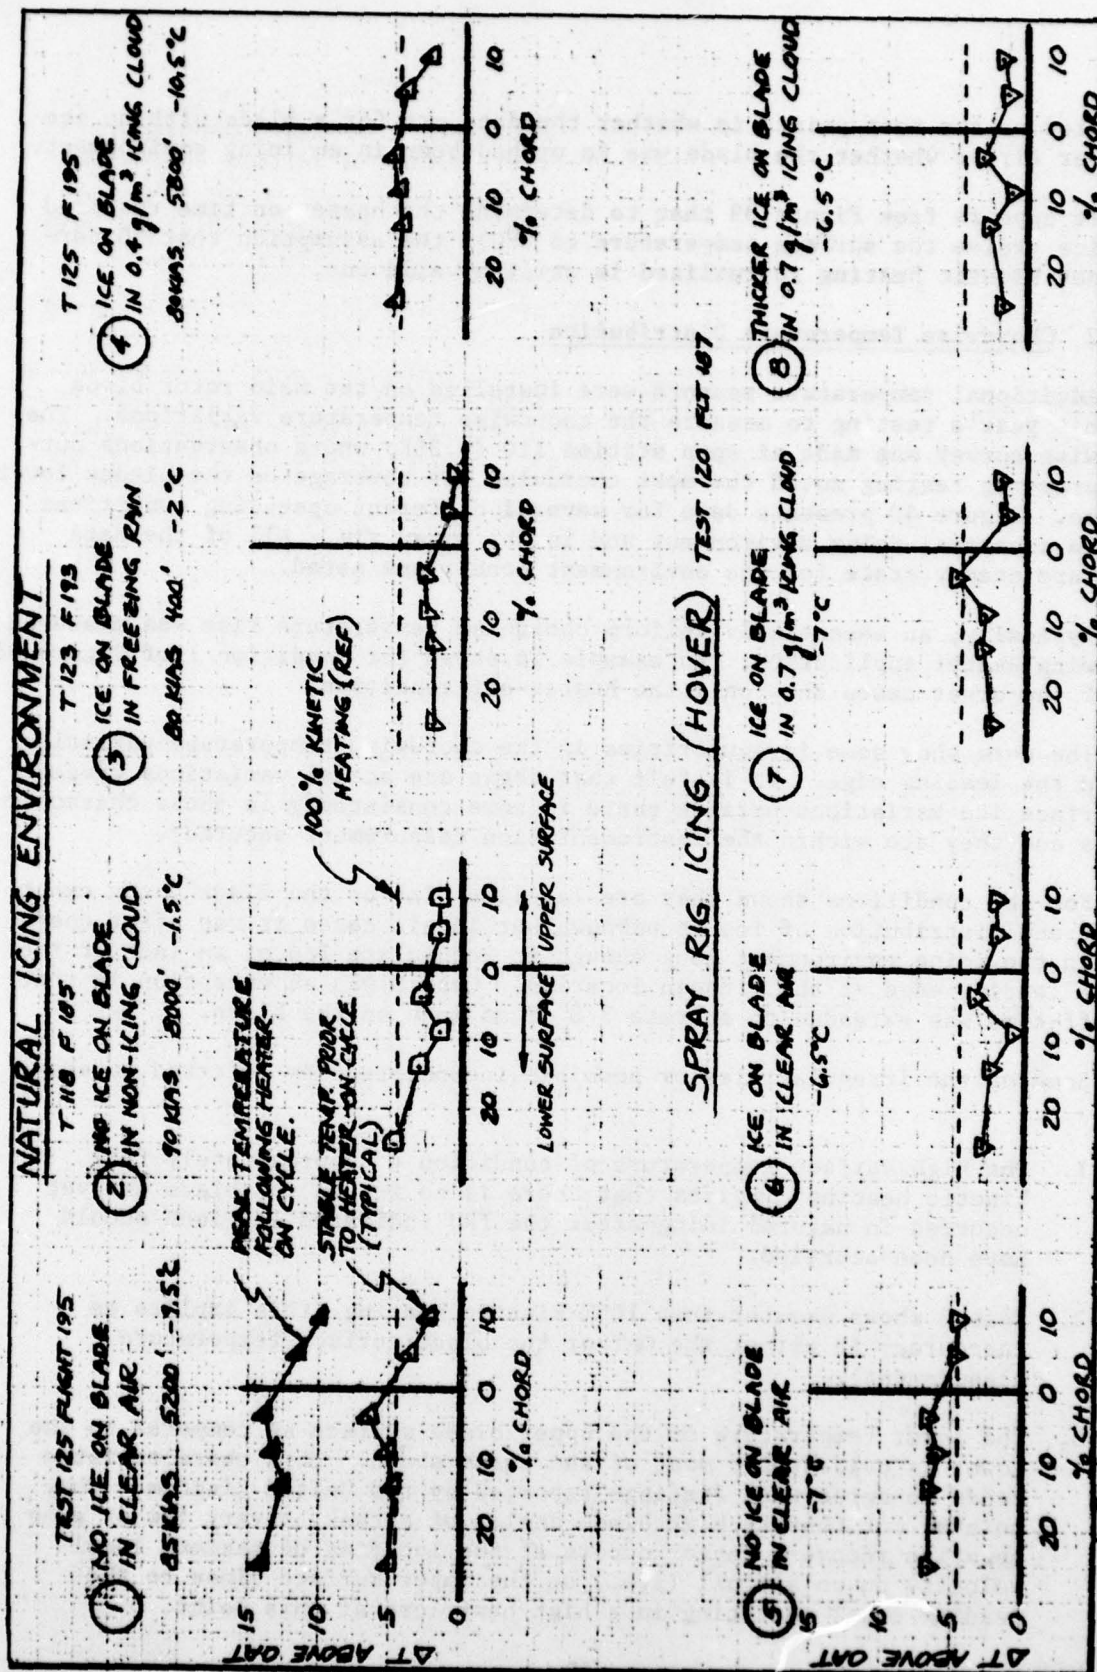
1. The high surface temperature of condition 4 (approximately full kinetic heating) implies that there is no ice on the blade and yet occurred in natural icing after the IRU indicated 1/4 inch should have been accreted.
2. Case 5 shows greater than 100% kinetic heating (this implies an inaccuracy in either the OAT or the blade surface temperature measurement).
3. The lower temperature on the upper blade surface as compared to the lower is evident for most of the cases shown. This characteristic tends to agree with findings reported by the United Kingdom. They pointed out that at high blade angles of attack, a very low or even negative recovery factor occurs at the location of maximum local velocity on an airfoil (i.e., on the upper surface close to the leading edge) resulting in a high heat loss at this point.

Figure 40. Blade Surface Chordwise Temperature Measurements at Span Station 110 (38% R).

In general, it appears that since the maximum chordwise temperature variation is only about 2°C, it is appropriate to use a uniform chordwise power density for deicing.

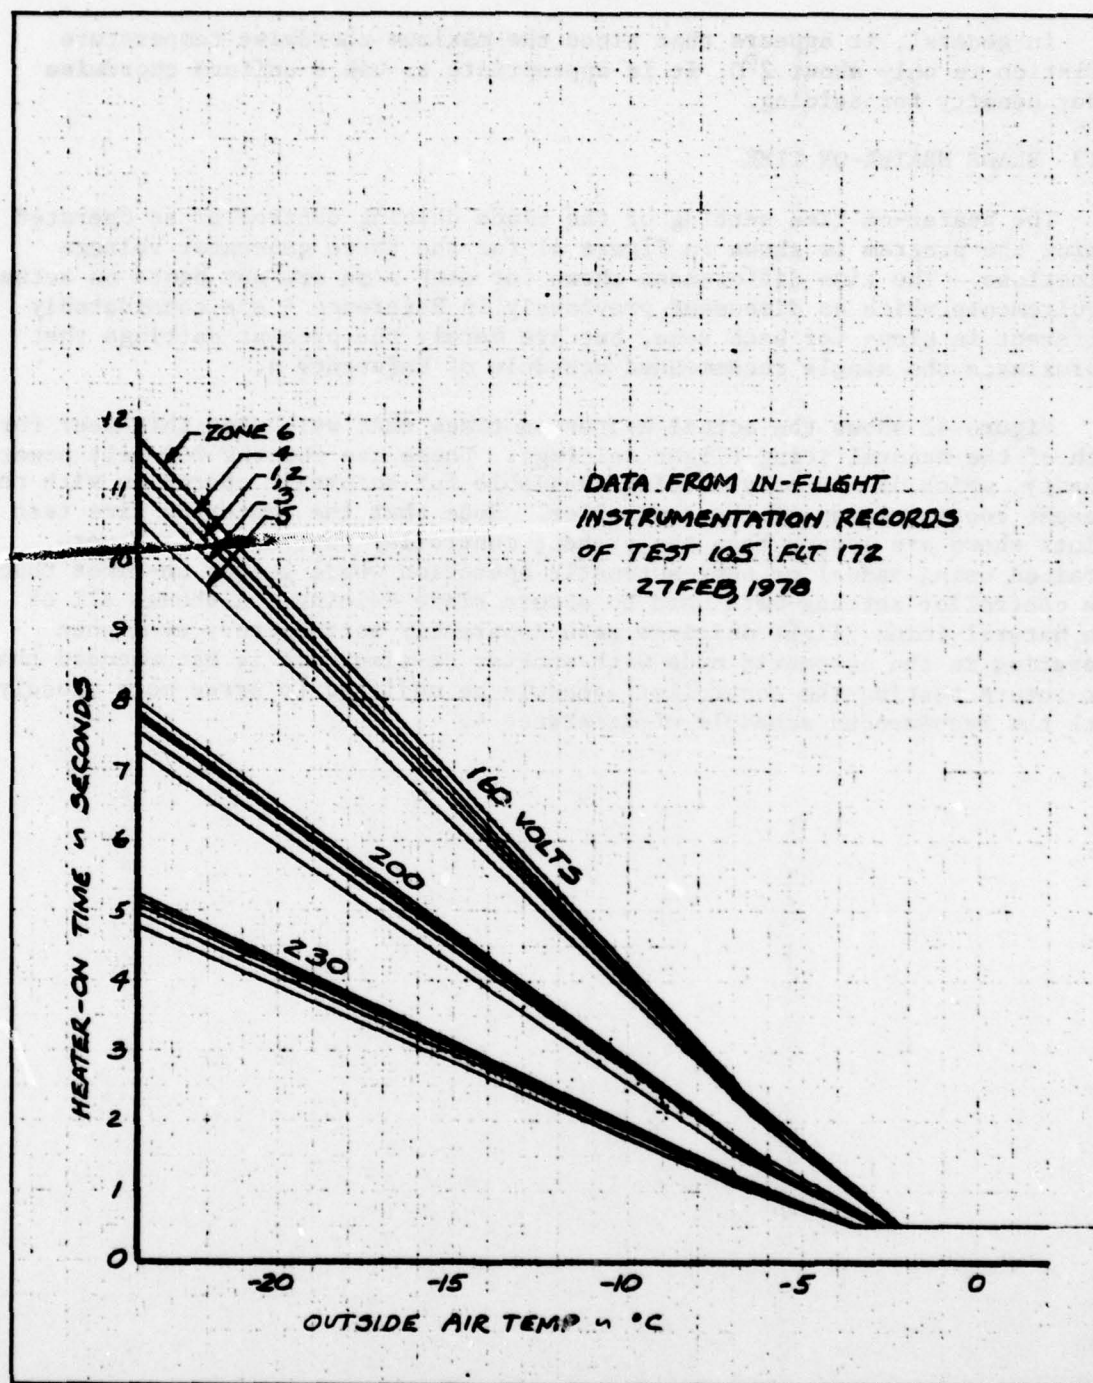
The heater-on time setting of the blade deicing controller as operated during the program is shown in Figure 41 for the three generator voltage selections. The time differences shown for each zone are not based on actual requirements, which as discussed previously in Reference 4 are considerably different in slope for each zone, but are merely the present settings that approximate the single recommended schedule of Reference 4.

Figure 41. Present Scheduling by Controller of Main Blade Heater-On Time.

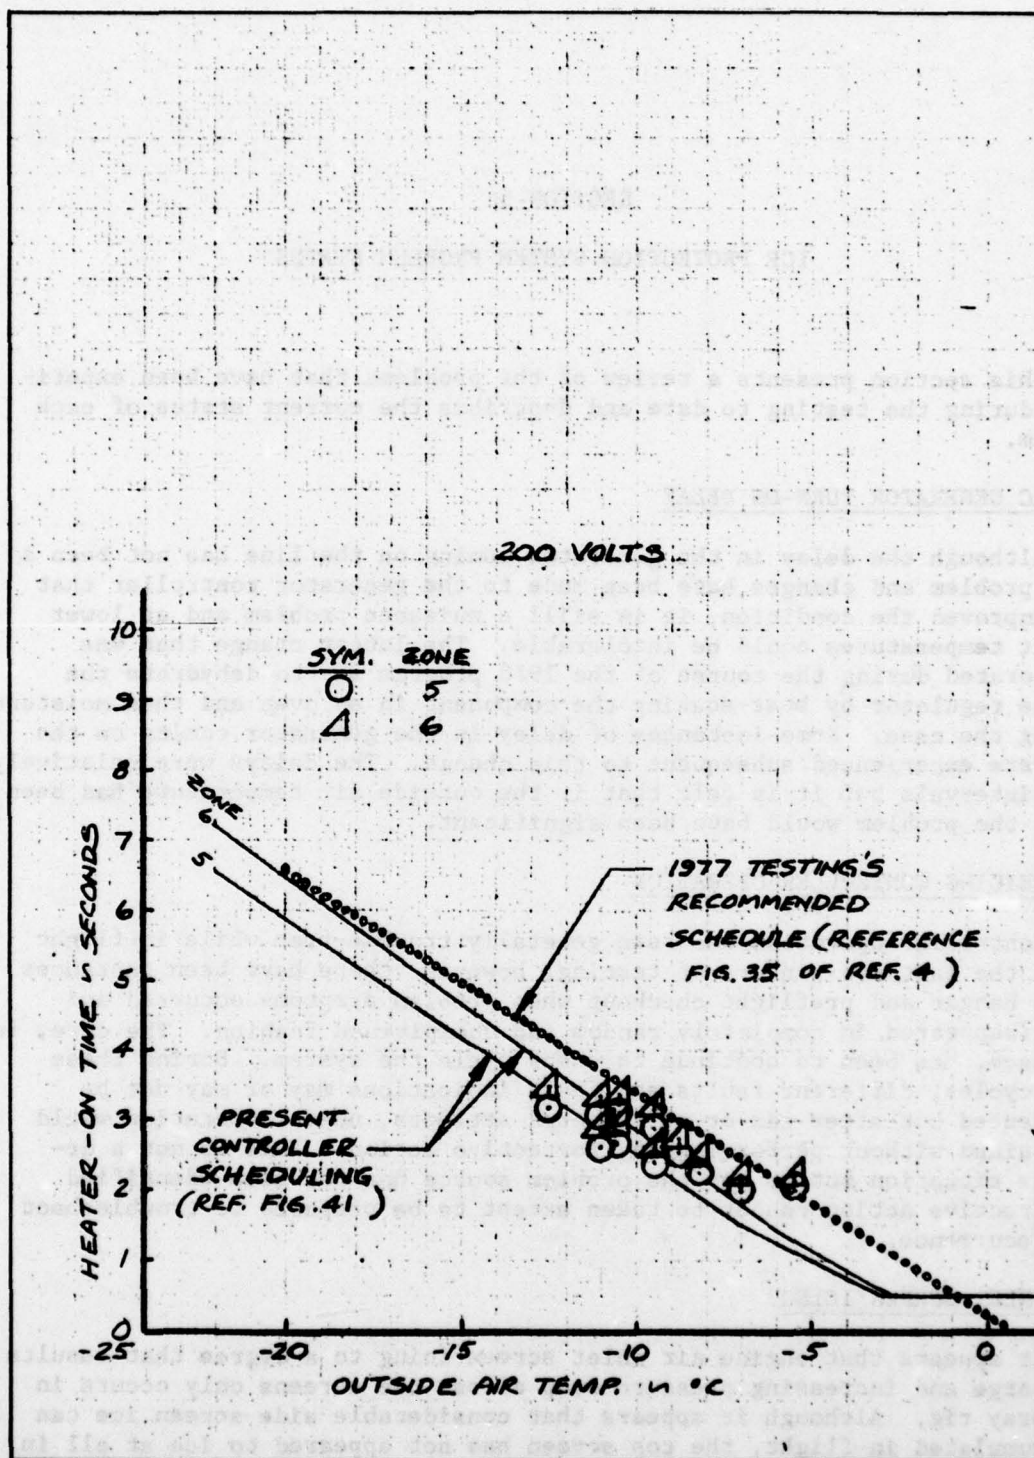
Figure 42 shows the actual heater-on times that were used this year for each of the natural icing flight deicings. These are for the 200-volt power density, which is the only setting available for automatic operation with the present configuration of the controller. Note that the heater-on time test points shown are longer than the present controller setting. These were obtained using manual or semi-automatic operation where longer on-times than the controller setting were used to assure blade deicing. Although all of the natural icing flight deicings were apparently satisfactory even when operating in the automatic mode with shorter on-times, it is recommended that for future testing the controller schedule be modified to agree more closely with the recommended schedule of Reference 4.

Figure 42. Main Rotor Heater-On Times Used on Natural Icing Flights During 1978 Testing.
